## Understanding the “Bermuda” roof – leading to its effective repair

Written by Sanders Frith-Brown for the Bermuda National Trust

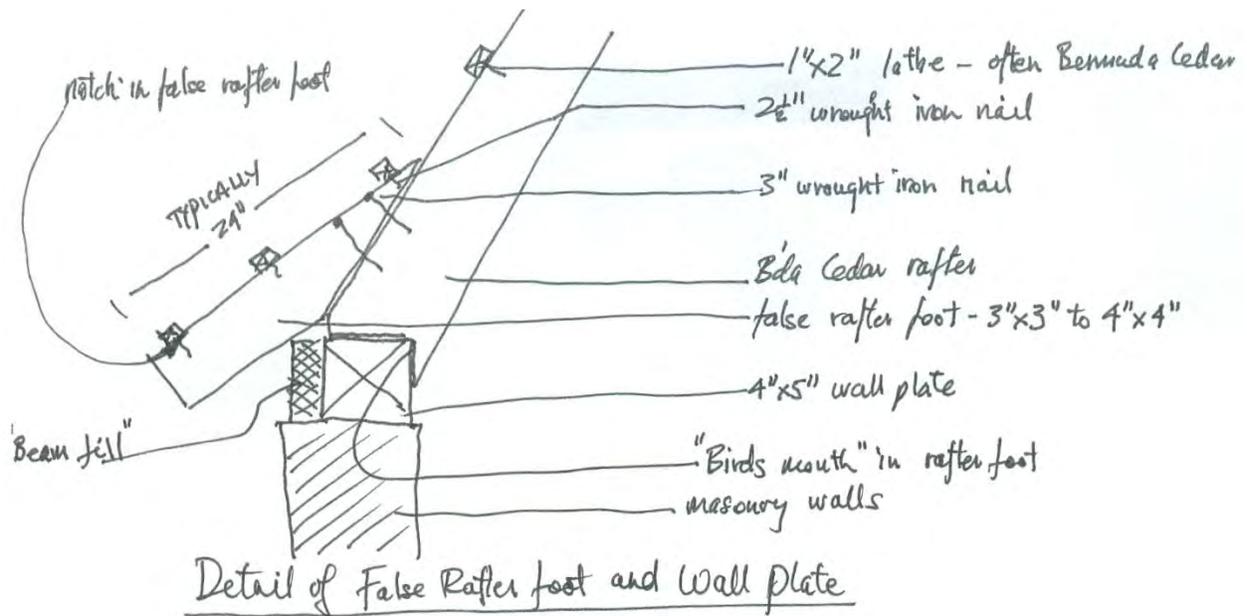
I can't work out where to put the drawing below. It doesn't seem to fit with any of the repairs and is substantially the same as the one coming under Rafter feet and false rafter feet except that it doesn't have slate. But it does have a bit of other information which I quite like.
